# 2020 Annual Performance Report Webinar

# COS Overview

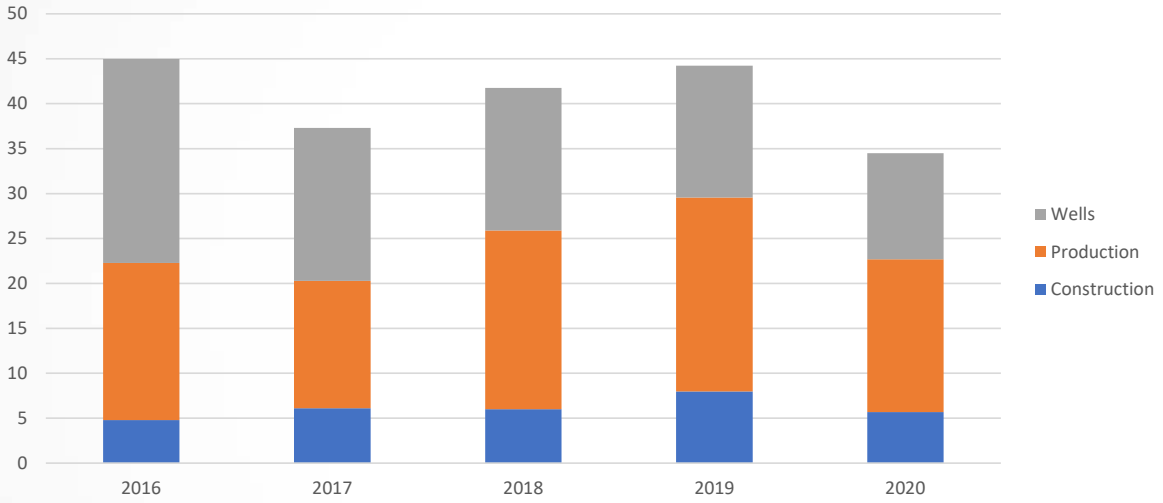
# Work Hours (Normalization Factor)

2016	2017	2018	2019	2020
<b>COS U.S. OCS Work Hours (Millions)</b>	45	37	41	44	34

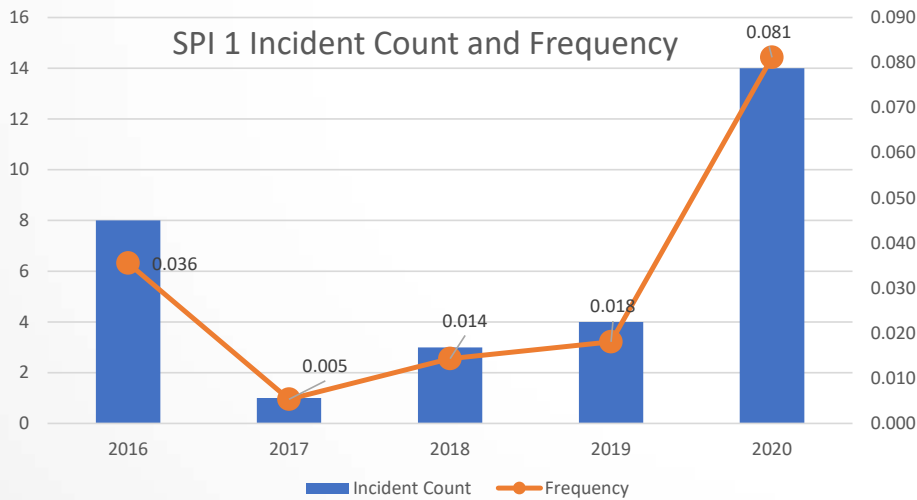
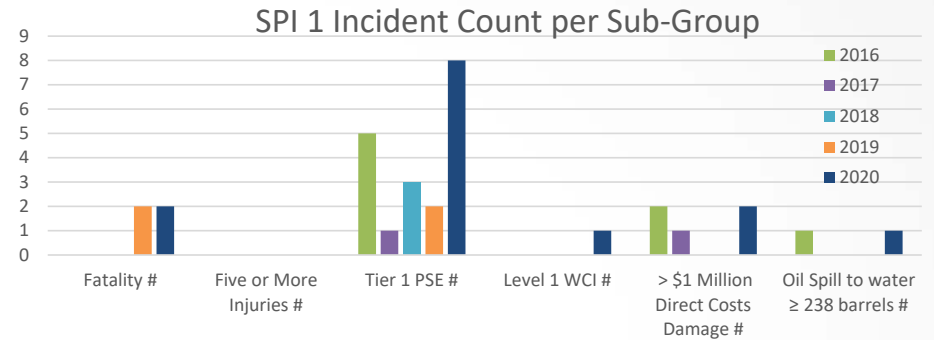
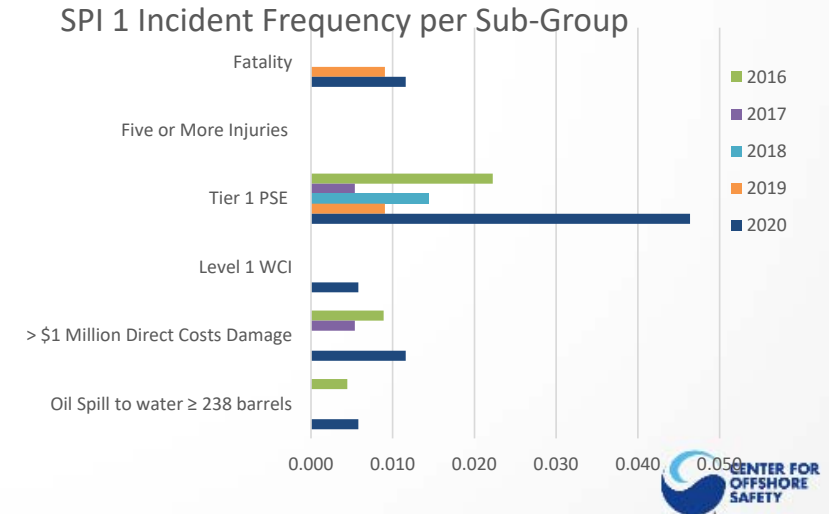
# SPI 1

- 1A – 2 Incidents involving 1 or more fatalities
- 1B – 0 Incidents with Injuries to 5 or More
- 1C – 8 Tier 1 Process Safety Events (PSE)
- 1D – 1 Level 1 Well Control Incidents
- **1E – 2 Incidents resulting in damage  $\geq$  \$1MIL**
- 1F – 1 Oil Spills to water  $\geq$  238 bbl

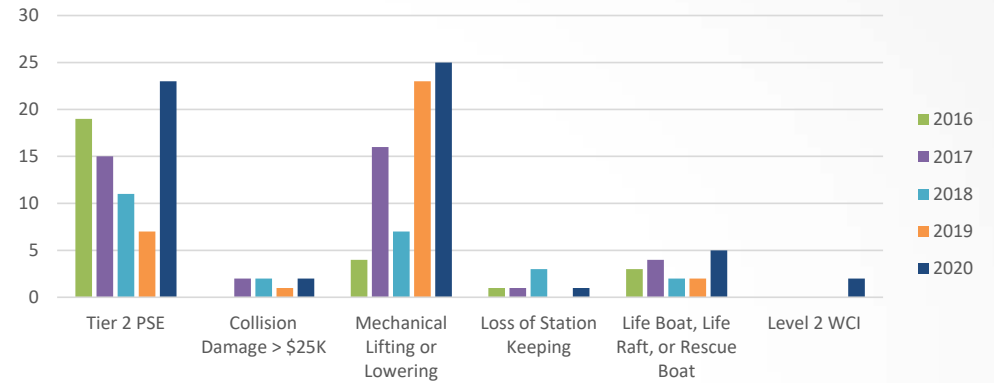
SPI 2 Incident Count per Sub-Group

- 2A – 23 Tier 2 PSE
- 2B – 2 Collision Damage ≥ \$25,000
- **2C – 25 Mechanical Lifting Incidents**
- 2D – 1 Loss of Station Keeping
- 2E – 5 Lifeboat, Life Raft, Rescue Boat Incidents
- 2F – 2 Level 2 Well Control Incidents

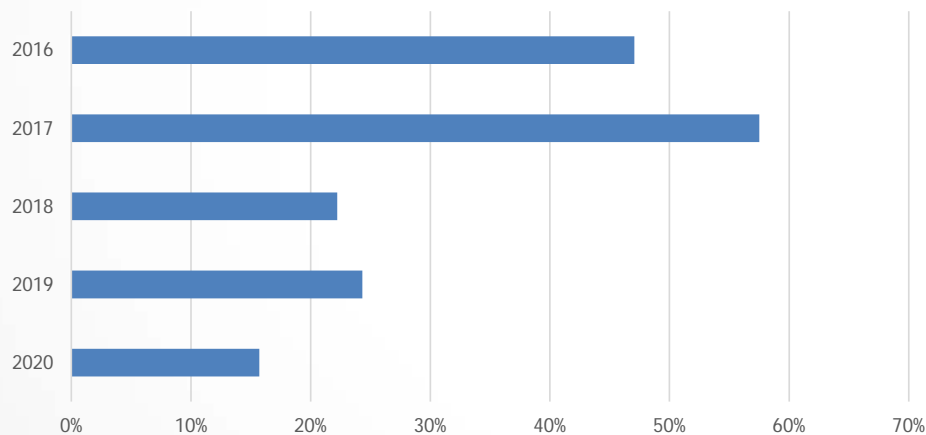
Equipment Failure as Contributing Factor

SPI 3 is the number of SPI 1 and SPI 2 incidents that involved failure of one or more pieces of equipment as a contributing factor.

- 70 SPI 1 and SPI 2 Incidents Reported
- 11 (16%) of those 70 cited failure of equipment as a contributing factor
- Equipment Types:
  - 3 - Process Equipment/Pressure Vessels/Piping
  - 3 - Shutdown Systems/Automated Safety Instrumented Systems
  - 3 - Mechanical Lifting Equipment/Personnel Transport Systems
  - 1 - Lifeboat/Life Raft/Rescue Boat/Launch and Recovery Systems
  - 1 - Other

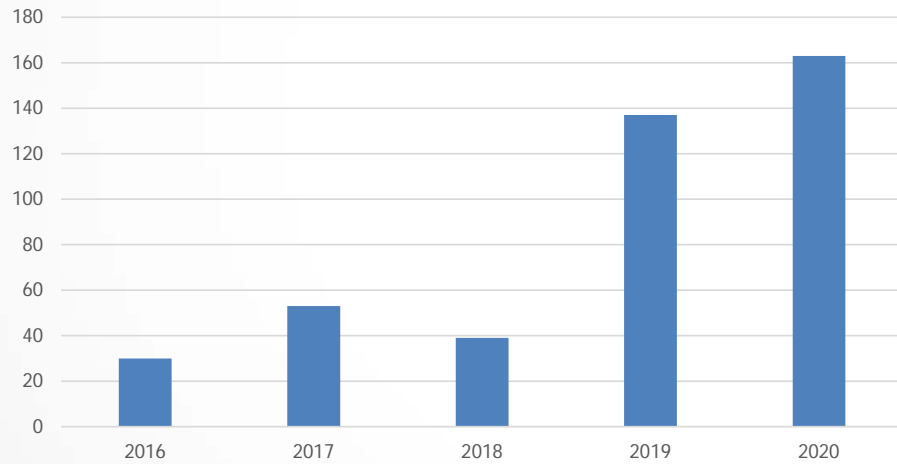
SPI 4 Incident Counts

SPI 4 is a crane or personnel/material handling operations incident.

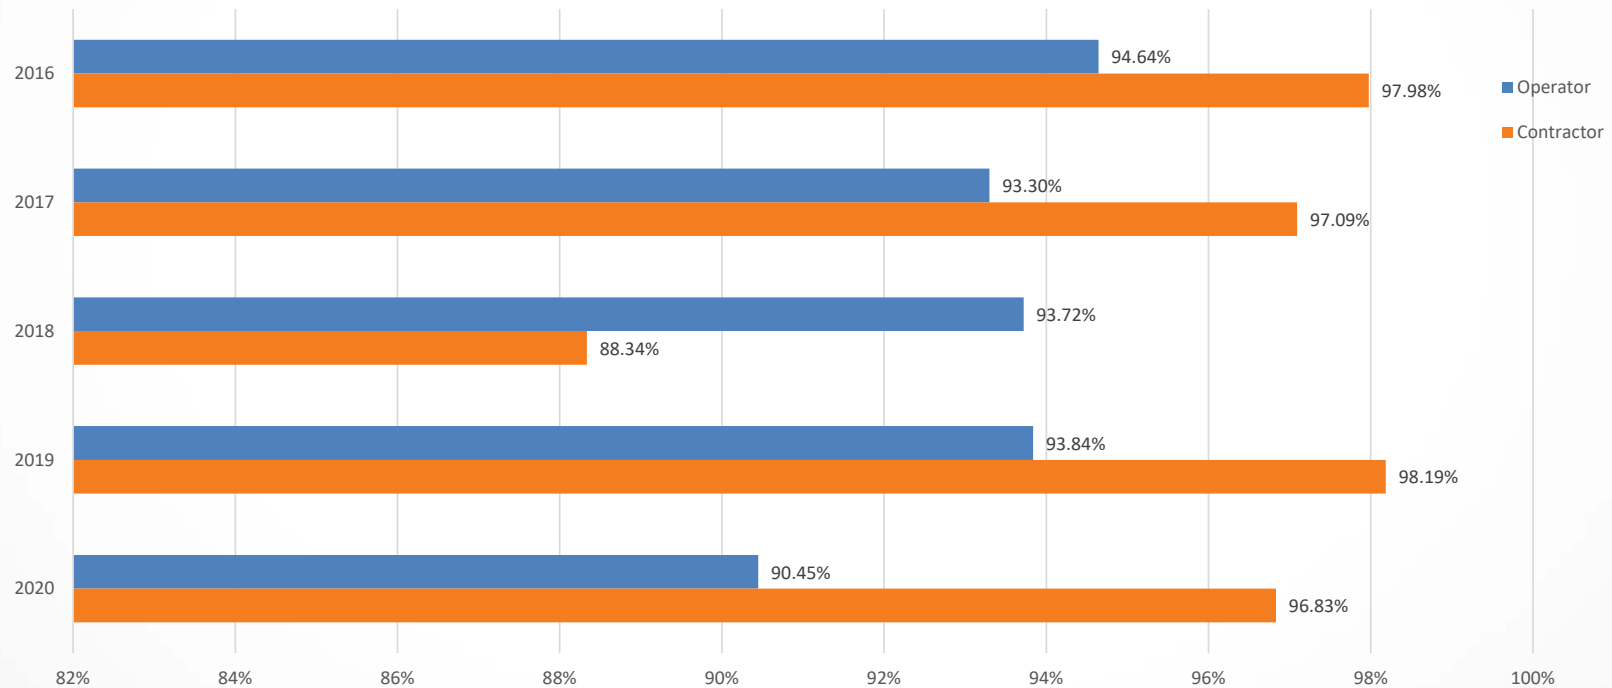
SPI 5 is the percentage of planned critical maintenance, inspection and testing (MIT) completed on time. Planned critical MIT deferred with a formal risk assessment and appropriate level of approval is not considered overdue.

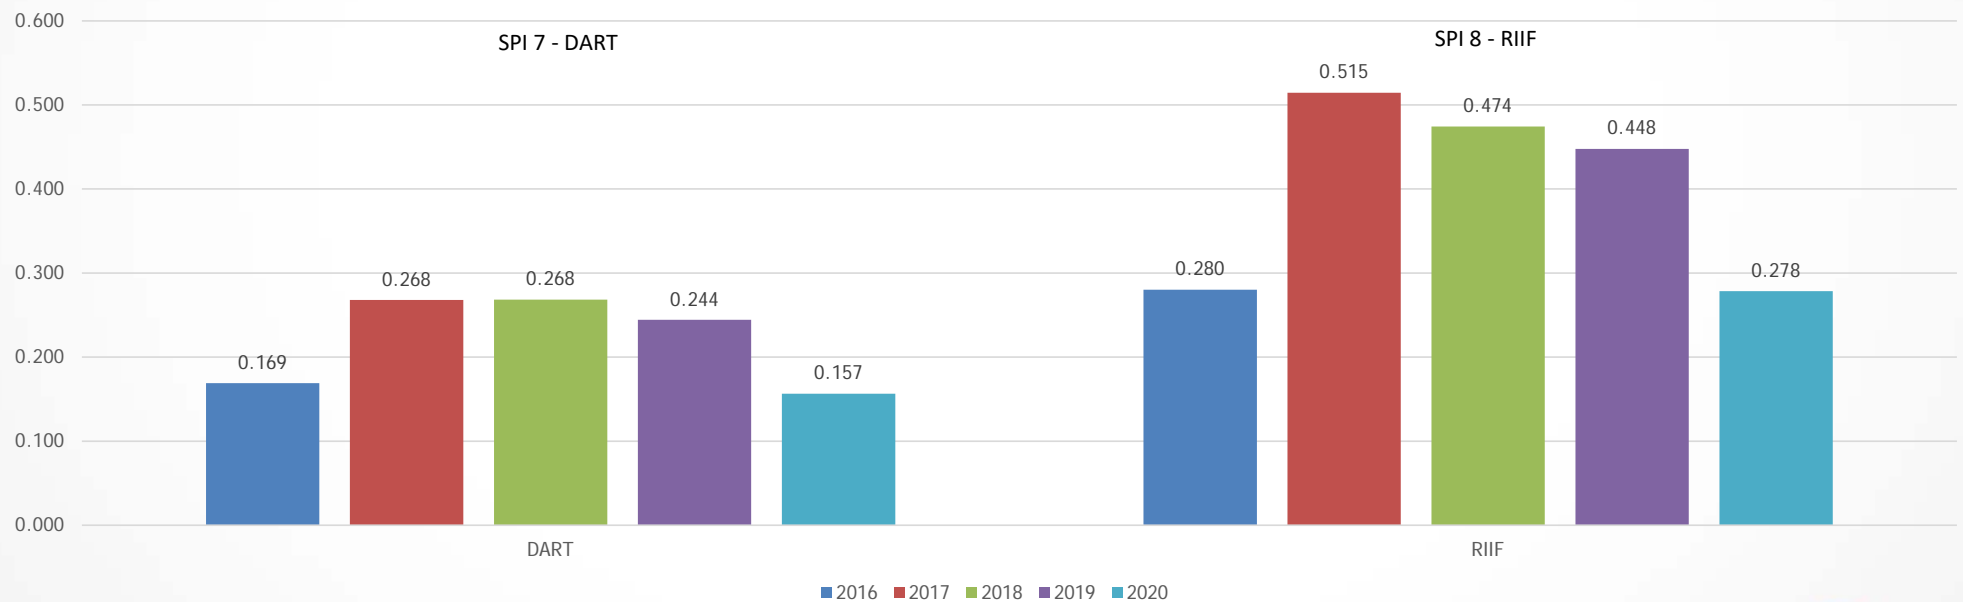
SPI 8 is the frequency of recordable injuries and illnesses (RIIF)

SPI 9 is the frequency of oil spills to water  $\geq 1$  barrel

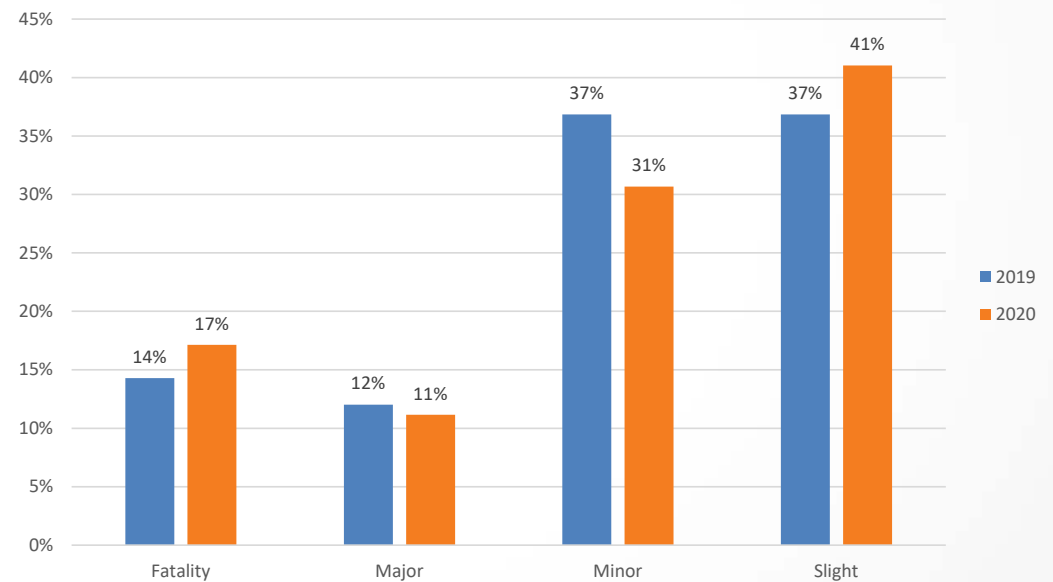
# SPI 10

SPI 10 is the severity *potential* of incidents involving a dropped object

- Based on definitions developed by the [DROPSONline](#) network
- 251 Dropped Objects reported
  - 103 Slight injury *potential*
  - 77 Minor injury *potential*
  - 28 Major injury *potential*
  - 43 Fatal injury *potential*
- 185 of 251 (74%) resulted in zero harm

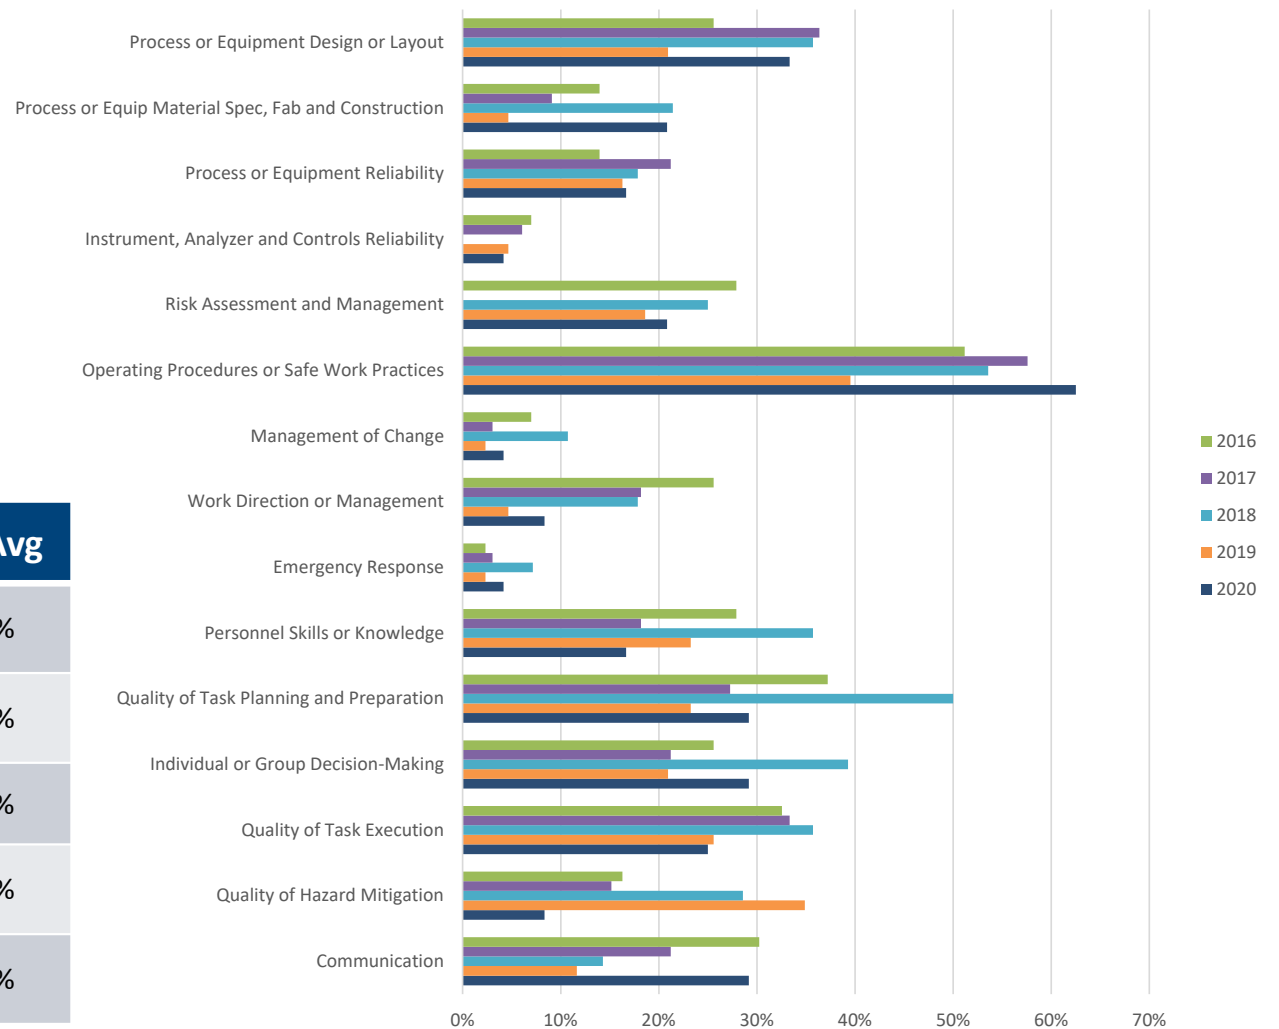
Areas for Improvement Distribution (US OCS only)

Top 5 AFI 2016-2020	2020	5-yr Avg
Operating Procedures or Safe Work Practices	62.5%	52.9%
Quality of Task Planning & Preparation	29.2%	33.4%
Quality of Task Execution	25.0%	30.4%
Process or Equipment Design or Layout	33.3%	30.4%
Individual or Group Decision Making	29.2%	27.2%
